## Completion of the lacquer repainting of the front side (paid area) of the Shurijo Castle Seiden and schedule of the repainting work for the left and right sections of the front side

I. Work Schedule for Lacquer Coating Repair, etc. of the Outer Side of Shuri Castle Seiden  
(FY2016 to FY2018)

## II. II. Situation of completion of kohai pillars and karahafu, and condition of deterioration of lacquer painting/coloring of the front side (left and right sections) of the Shuriijo Castle Seiden

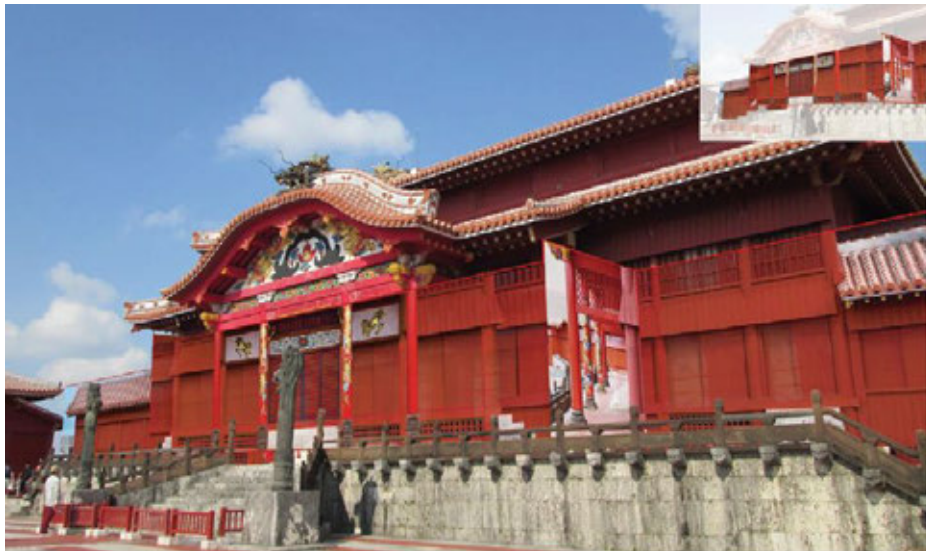
Image of installation of scaffolding during the work period

\* As this is a composite image, it differs from the actual appearance.

\* With regard to the lacquer repainting work for the front side of the Shurijo Castle Seiden, we plan to install scaffoldings using wrapping sheets for the lower sections to prevent causing a feeling of discomfort as much as possible. Other

than that, we plan to use meshed sheets for the work sections so that visitors can view a part of how the work is going on.

(However, we may use cloth coverings for protection against ultraviolet rays and controlling temperature and humidity.)

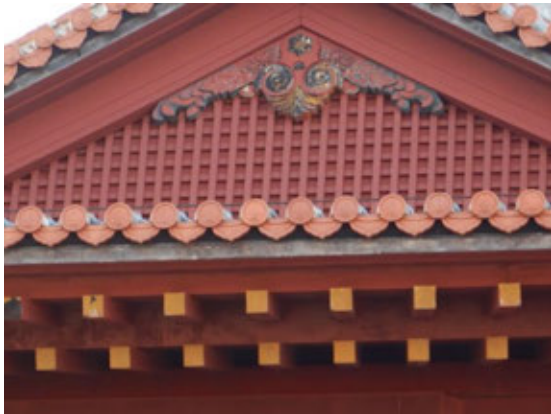
【Gabled section: Gegyo (decoration board), rafters, etc. -- colors have faded】

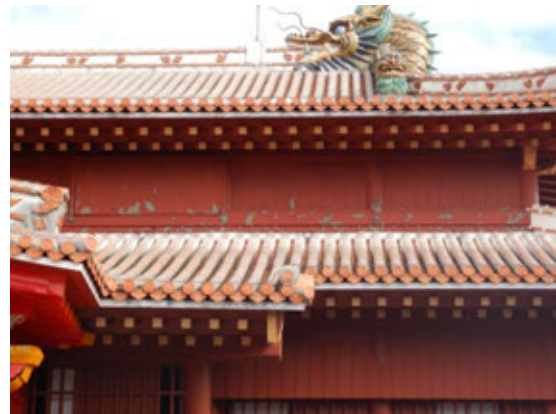
【Outer wall section - the lacquer has peeled off】

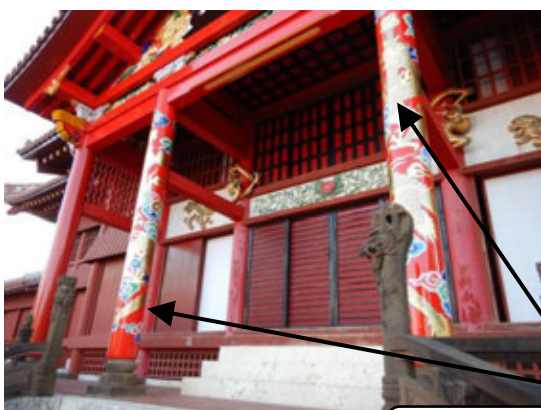
【Kohai pillars】

Repainting completed

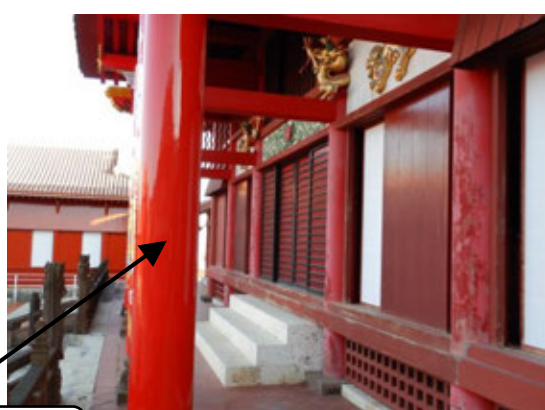
【Kohai inner pillar, doorsill - the lacquer has deteriorated】

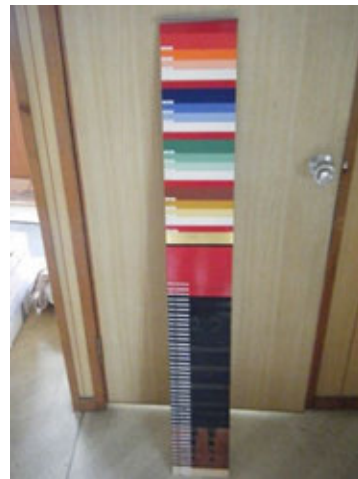
Explanation of vermillion color painting process with a teita (hand plate/board)
